Failure Analysis of a CH-47 Horizontal Hinge Pin Assembly, P/N 114RS226

ARL-TR-4011

December 2006

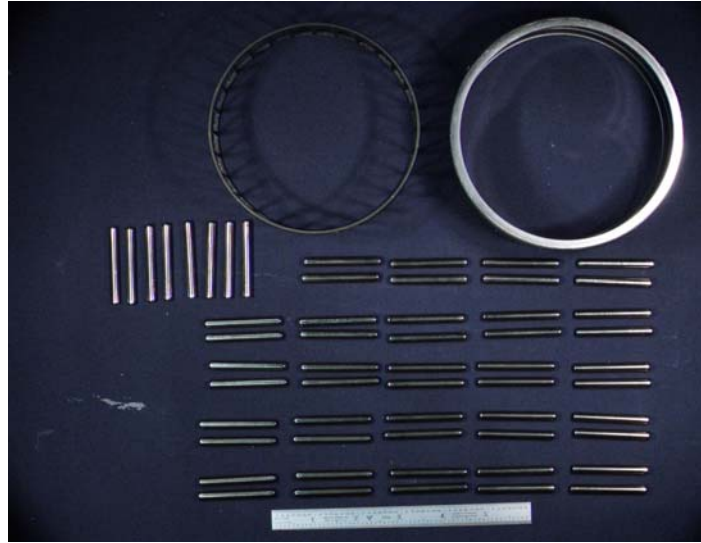
Figure 1. The rollers, cage, and sleeve of the lead roller bearing set. The scale is 6 inches in length.

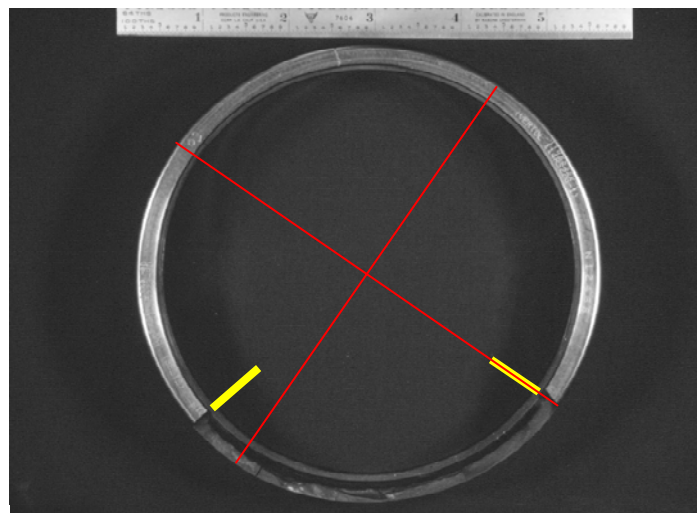
The lag-roller bearing set displayed much more damage than the lead roller bearing set. The lag-roller bearing set consisted of a fractured lag ring with a spalled raceway and eight rollers that exhibited extensive surface damage and spalling—one of which fractured into two pieces. The lag ring's fracture extended over an arc length of approximately 4 in (see figures 2 and 3). The lag ring's fracture and all secondary cracking were relegated to portions of the ring that exhibited raceway spalling (see figure 4). Inspection of the lag ring's fracture surfaces via light-optical microscopy revealed multiple thumbnail-shaped beach marks. These marks indicate fracture was likely initiated by fatigue from multiple sites along the spalled raceway surface and propagated by fatigue to the outer diameter of the ring (see figure 5).

Figure 2. View of the lag ring showing that the fractured region encompassed an approximately 4-in arc length of the ring's circumference.

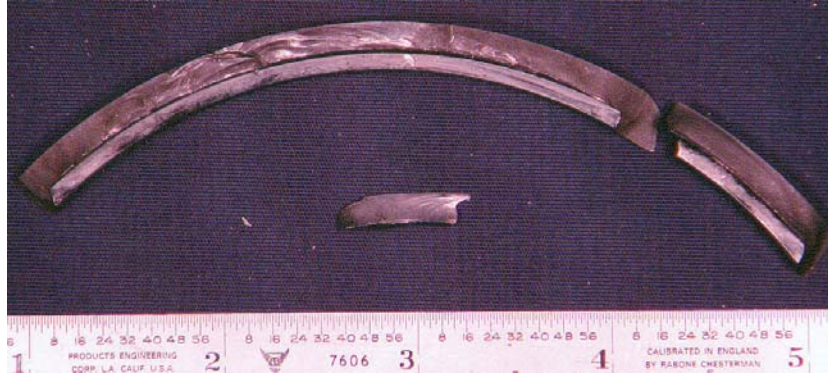
Figure 3. Three pieces of material that fractured from the lag ring depicted in figure 2.

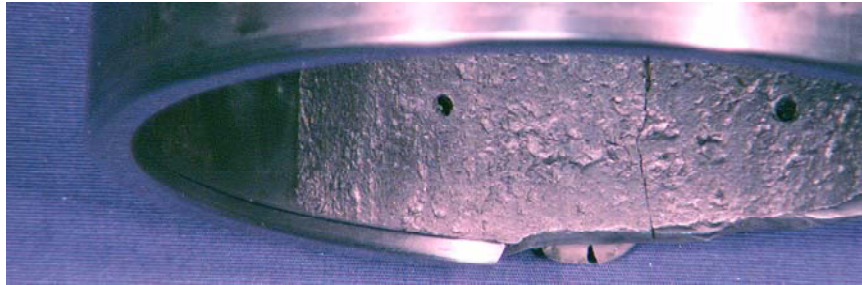
Figure 4. The lag-ring raceway exhibited a spalled surface topography. Fracture and cracking were relegated to the portion of the lag ring exhibiting a spalled raceway surface.

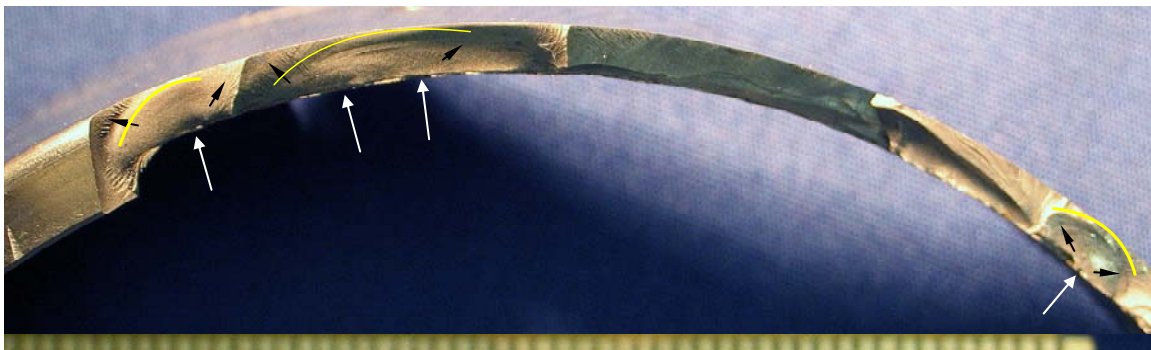
Figure 5. Lag-ring fracture exhibiting beach marks (parallel with yellow lines), river patterns (parallel to black arrows), and multiple origins (white arrows). Scale demarcations at image bottom denote 1/64-in spacing.

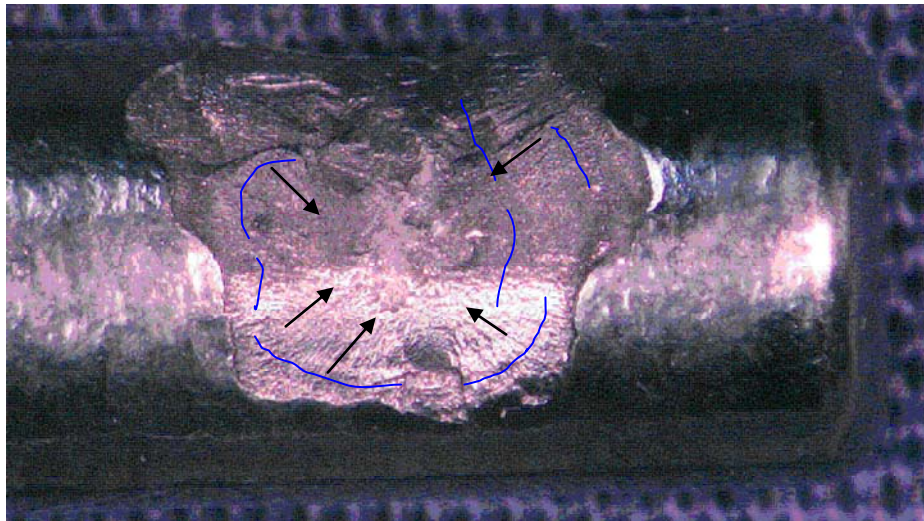
Eight of the lag rollers exhibited surface damage and spalling (figure 6). Many of the spalled regions within the rollers exhibited river patterns and concentric beach marks, which indicate that spalling had initiated and propagated due to fatigue from a subsurface origin—a typical failure mode of RCF. One of the eight damaged lag rollers fractured into two pieces (figure 7).

Figure 6. Typical surface damage and spalling exhibited on the lag rollers. The topography of the surface created by spalling exhibited the beach marks (parallel with the blue lines) and river patterns (parallel with the black arrows) indicative of subsurface crack initiation and propagation by RCF. Magnified $\sim 5.7\times$.

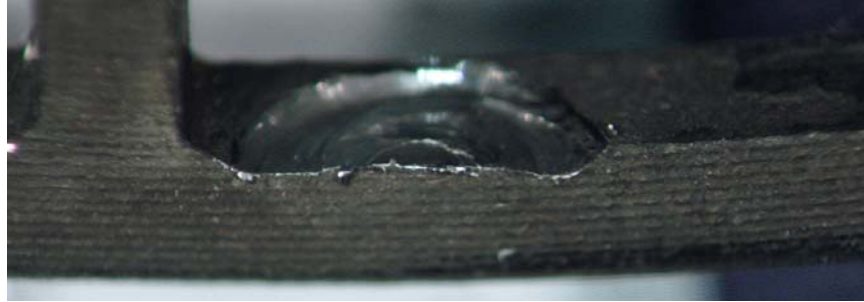
The lag-ring bearing cage exhibited wear damage likely due to high-contact loads with the flat ends (or sides) of the mating rollers (see figure 8).

Figure 8. Inner surface of the lag retainer exhibiting wear damage caused by contact with the mating rotating roller—indicative of high contact loads between the two parts. Magnified 9.7 \times .

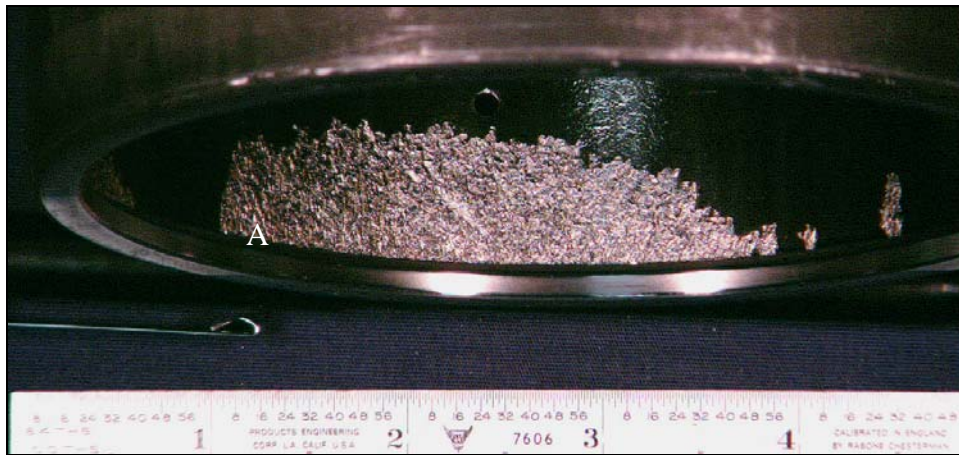
The only damage exhibited by the lead-roller bearing set was the spalled raceway surface of the ring (see figures 9 and 10). The surfaces of the mating lead rollers and the cage did not exhibit surface damage.

Figure 9. Lead-ring raceway spalling.

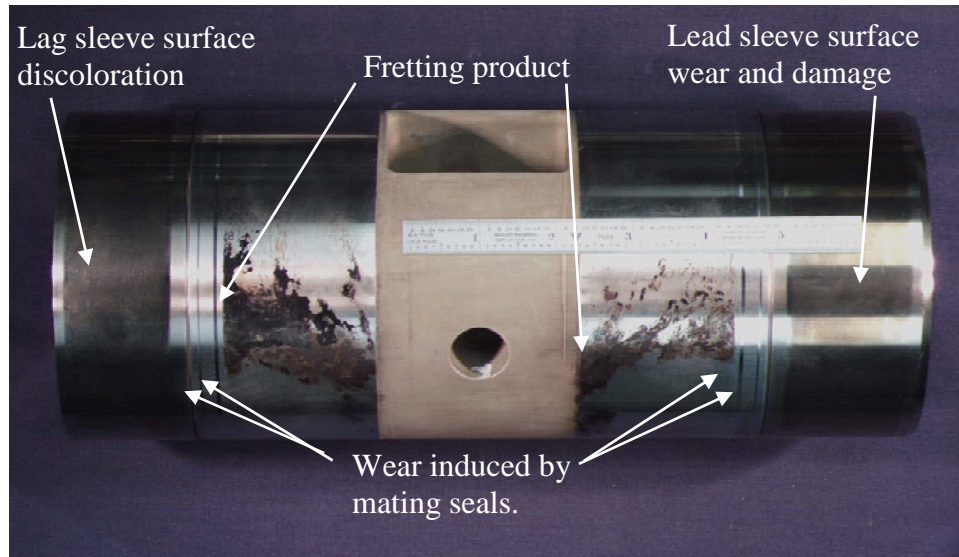
The lead-sleeve and lag-sleeve raceways of the HHP were discolored (see figure 11). The lag sleeve was darker than the lead sleeve. Neither of the two sleeves exhibited a spalled surface. It appeared that the raceway discoloration in each sleeve was due to contact with the mating rollers and the oil contaminated with roller spalling and/or ring-spalling debris.

Figure 11. The HHP in the as-received condition exhibited discolored lead-sleeve and lag-sleeve raceways. The chrome-plated surface of the HHP between the sleeves exhibited wear induced by mating seals and fretting product created by the relative motion between the HHP and a mating pitch-shaft sleeve.

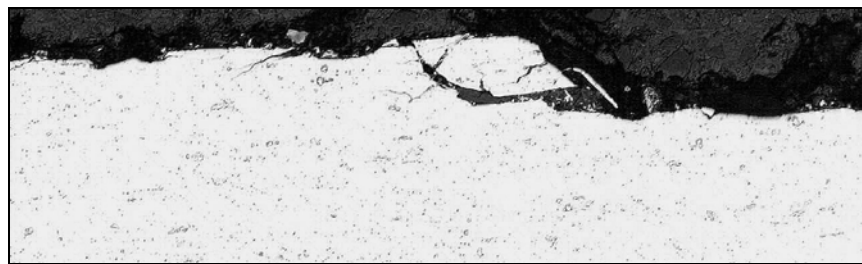
Because the level of spalling had progressed too far in the region subjected to contact with the mating rollers, regions of the lag-ring raceway exhibiting the onset of spalling could not be found and examined metallographically. A metallographic specimen cut from the spalled region and examined in the as-polished condition exhibited the carbide inclusions typical of this alloy, but not any microstructural defects that may have contributed to the raceway spalling (see figure 12).

Figure 12. Micrograph of an as-polished section cut from the spalled portion of the lag-ring raceway. No microstructural anomalies were observed. Magnified 200 \times .

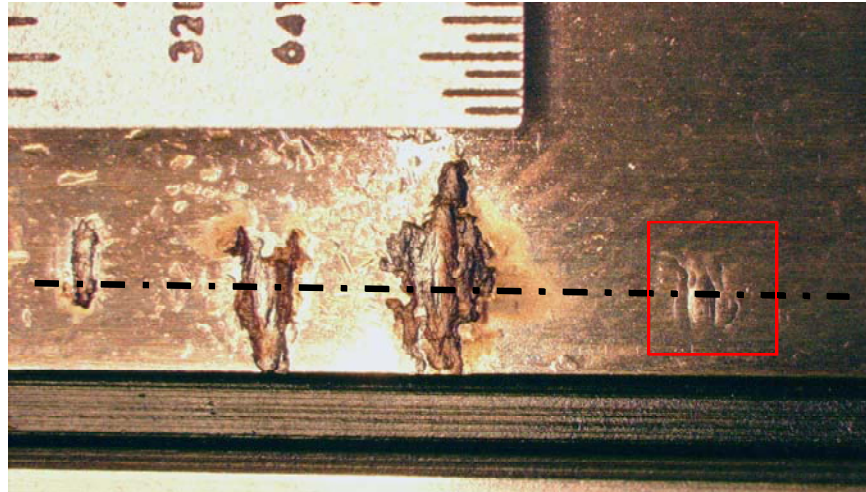
A metallographic cross section was produced from a portion of the lead ring exhibiting the onset of spalling (see figures 13 and 14). This metallographic cross section exhibited subsurface cracks—some of which didn't open to the raceway surface and some of which did. Figure 15 shows a subsurface crack parallel with the raceway surface that appeared to be a subsurface crack that initiated RCF. Figure 16 shows a subsurface crack that opened to the raceway surface at a 45° angle—an angle associated with the shear-lip formation that occurs typically during

Figure 13. Spalling and cracking on the raceway of the lead ring. Dashed line represents section made for metallographic examination.

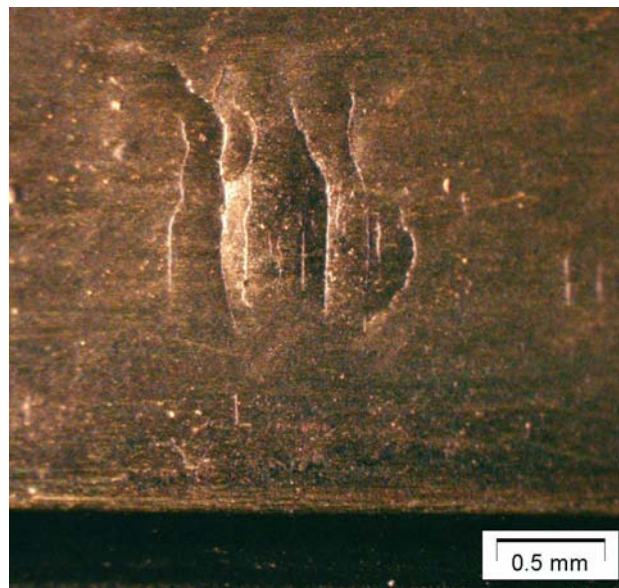
Figure 14. Detail of lead-ring raceway cracking depicted within red box in figure 13—likely the onset of spalling.

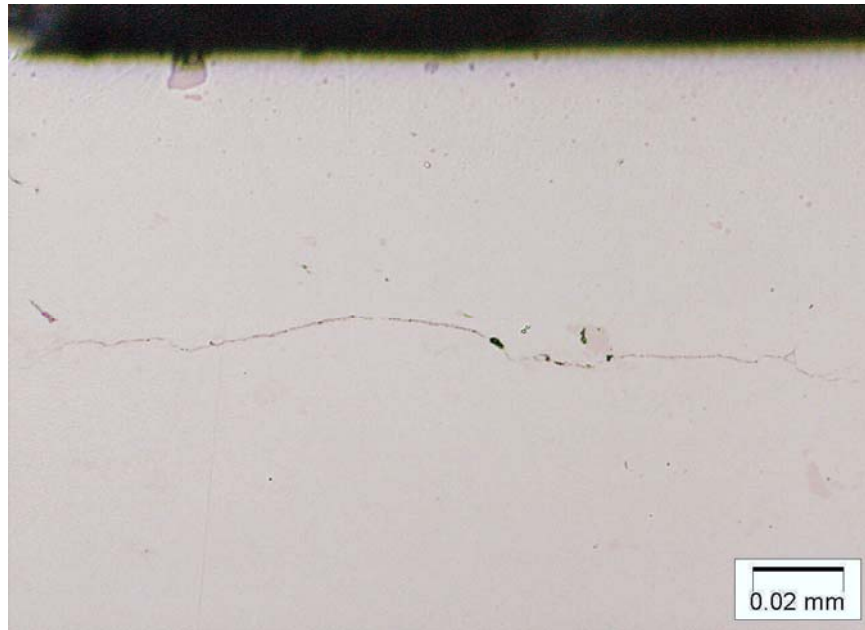
the final stage of an overload fracture. Etching the subsurface crack (figure 15) with Vilella's reagent (5 mL of hydrochloric acid, 1g of picric acid, and 100 ml of ethanol) revealed the presence of local microstructural alterations (see figure 17). Microstructural alterations are the localized plastic deformations created by the subsurface cyclic stresses of RCF. These features create planes of weakness on which cracks can propagate (3).

Figure 15. Metallography of the lead-ring region depicted in figure 14 revealed a subsurface crack running parallel with the lead ring's raceway surface.

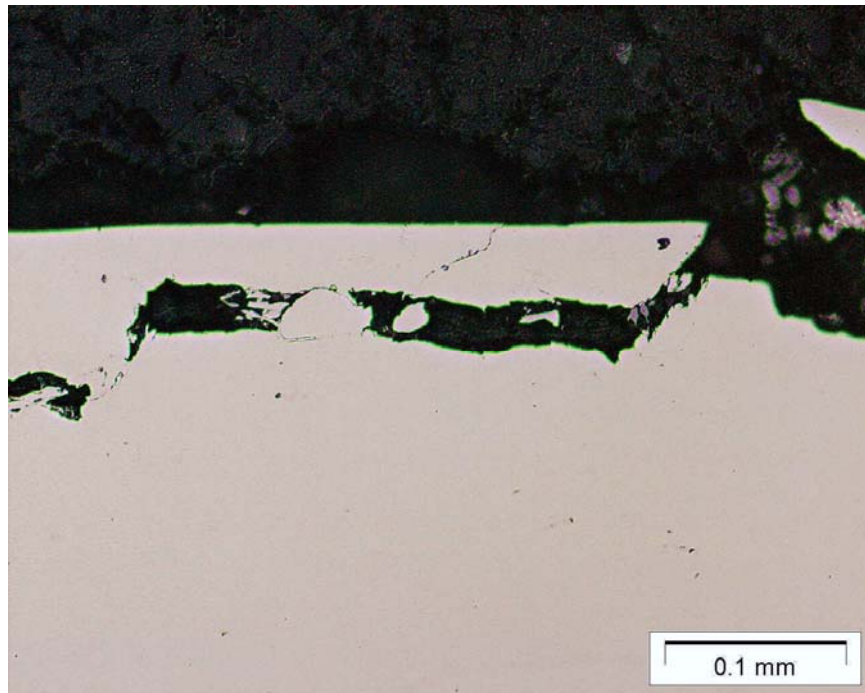
Figure 16. Metallography of the spalled and cracked area to the left of the area depicted in figure 13 revealed cracking parallel with the raceway surface and 45° to the raceway surface.

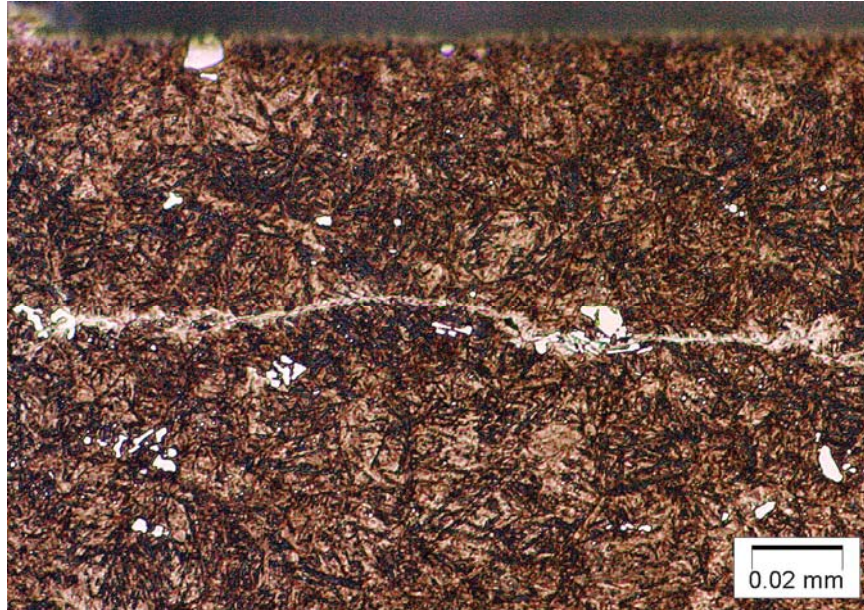
Figure 17. Etching the microstructure of the subsurface crack depicted in figure 15 revealed the presence of microstructural alterations—a feature associated with RCF. Etchant: Vilella's reagent.

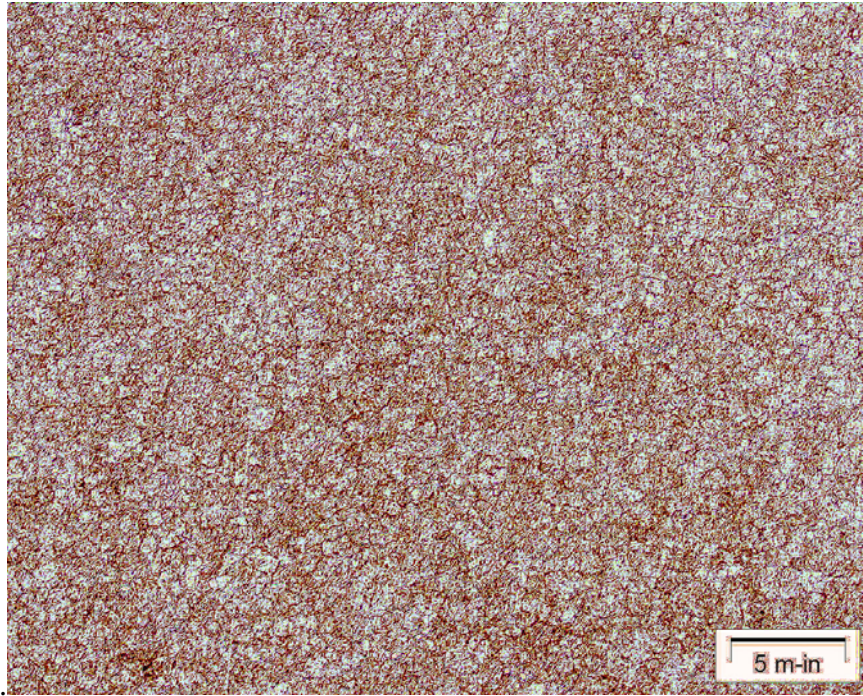
The average grain size of the rings and rollers (examined at 100× magnification) was 8.5, with an occasional grain as large as ASTM no. 6 (see figure 19). This met the RBC Heat Treatment Specification HT-8 requirement for an average grain size of ASTM no. 8 or finer, with occasional grains as large as ASTM no. 6. The grain size was determined using transparency overlays of various grain sizes conforming to ASTM E112 (4). The microstructure of all other metallographic ring and roller specimens exhibited a similar grain size.

Figure 19. Micrograph of the lag-ring microstructure showing a grain size that conformed to the required average ASTM grain size no. 8 or finer, with occasional grains as large as ASTM grain size no. 6. Etchant: Vilella's reagent. Magnified 100×.

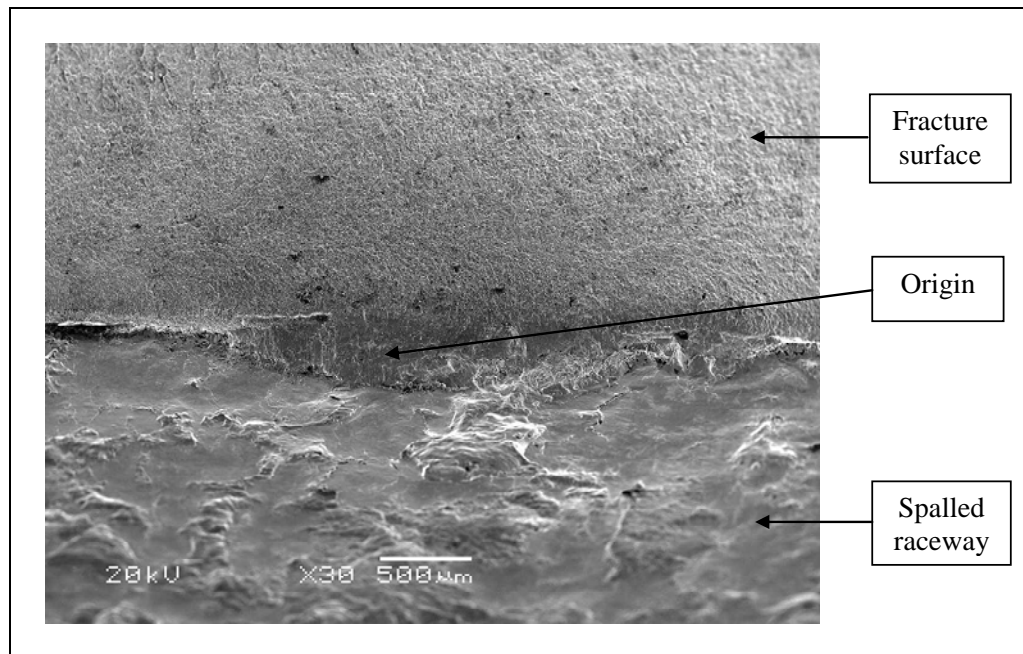
Scanning electron microscopy (SEM) revealed that a lag-ring fracture origin identified by light-optical microscopy (see the origin adjacent to the white arrow with the letter A in figure 5) exhibited a smeared surface topography (see figures 24 and 25). It was not clear if the surface topography of the crack origin was smeared due to the repeated closure and rubbing of the initiating crack or to post-fracture handling. However, there was no indication that the fatigue crack initiated anywhere except the spalled raceway. Areas of the fracture face that were not smeared were predominantly transgranular—the expected fracture morphology for fatigue failures of this alloy (see figure 26).

Figure 24. One of the fracture origins on the surface of the lag ring (identified via light-optical microscopy and labeled with the nomenclature A in figure 13).

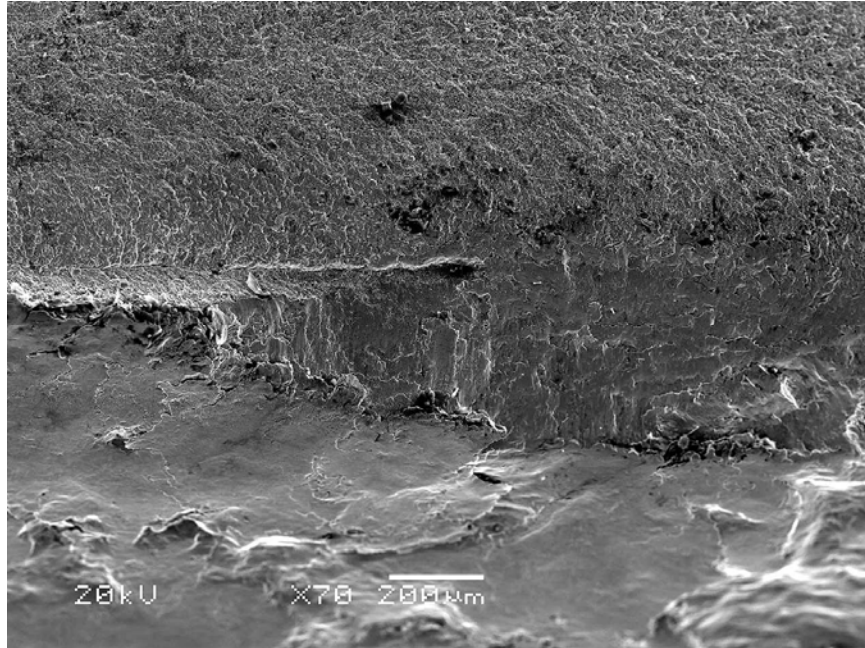
Figure 25. Detail view of the origin shown in figure 24 showing that the topography of the origin is smeared.

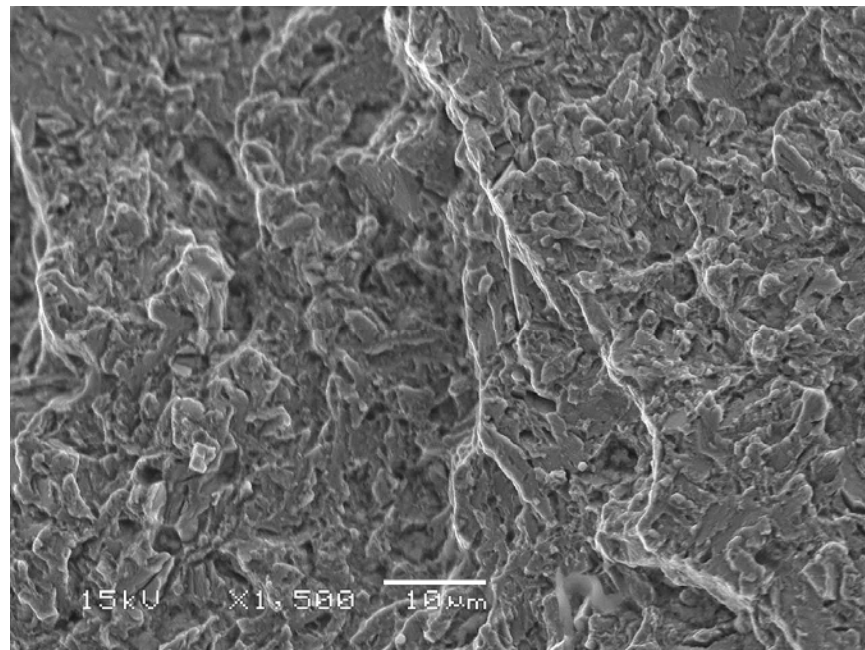
Figure 26. The fracture morphology of the lag ring was transgranular—typical of a fatigue-fracture mode.

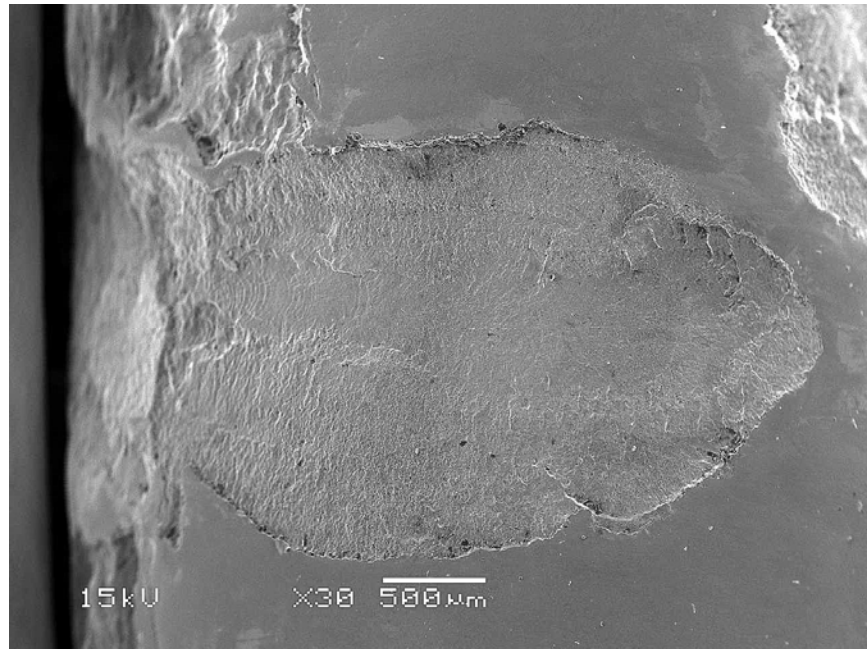
The spalling exhibited by several of the lag rollers was also examined via SEM (see figure 27). The fracture topography of the spalled surfaces exhibited beach marks and a transgranular surface morphology (see figures 28 and 29)—characteristics of an RCF mode of failure.

Figure 27. Surface spalling (fatigue pit) exhibited by a lag roller—typical of the spalling observed on the other lag rollers.

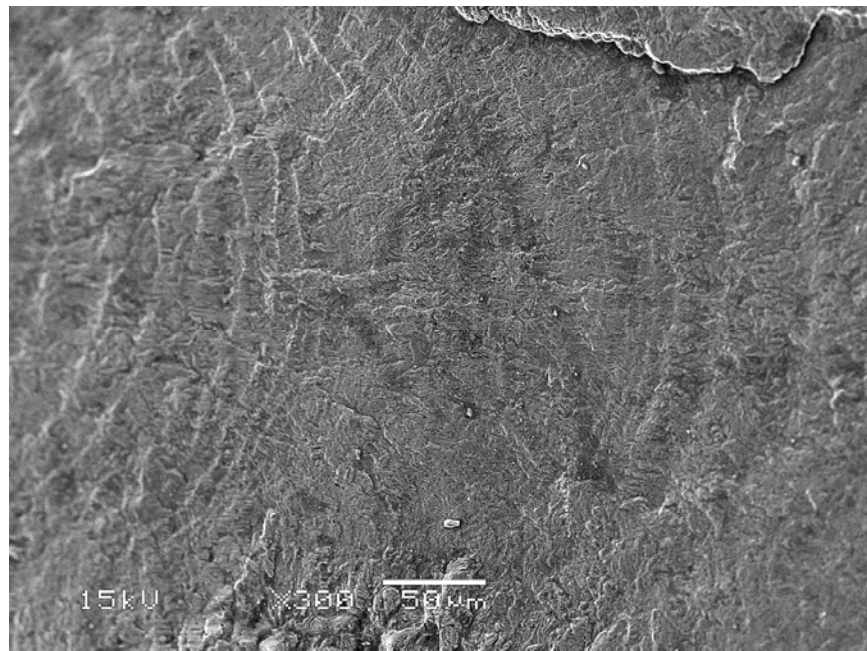
Figure 28. Detail of the spall depicted in figure 27 showing the beach marks typical of RCF-induced spalling.

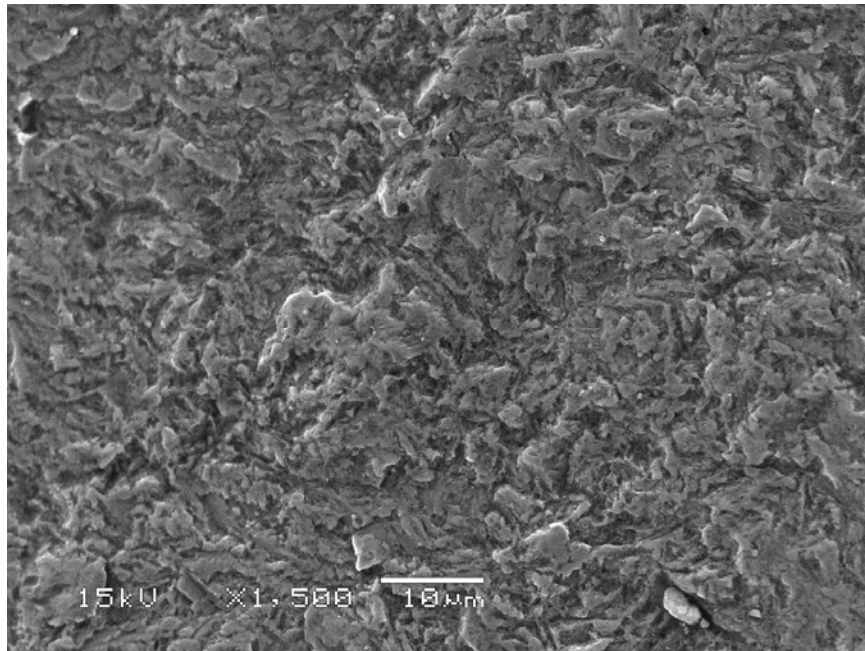
Figure 29. Detail of figure 28 showing the transgranular fracture morphology of the spalled surface typical of RCF-induced spalling.
